PHASE I ENVIRONMENTAL SITE ASSESSMENT

FORMER KAPLAN BUILDING **891 PROVIDENCE ROAD SCRANTON** LACKAWANNA COUNTY **PENNSYLVANIA**

> 24 July 2017 200075901

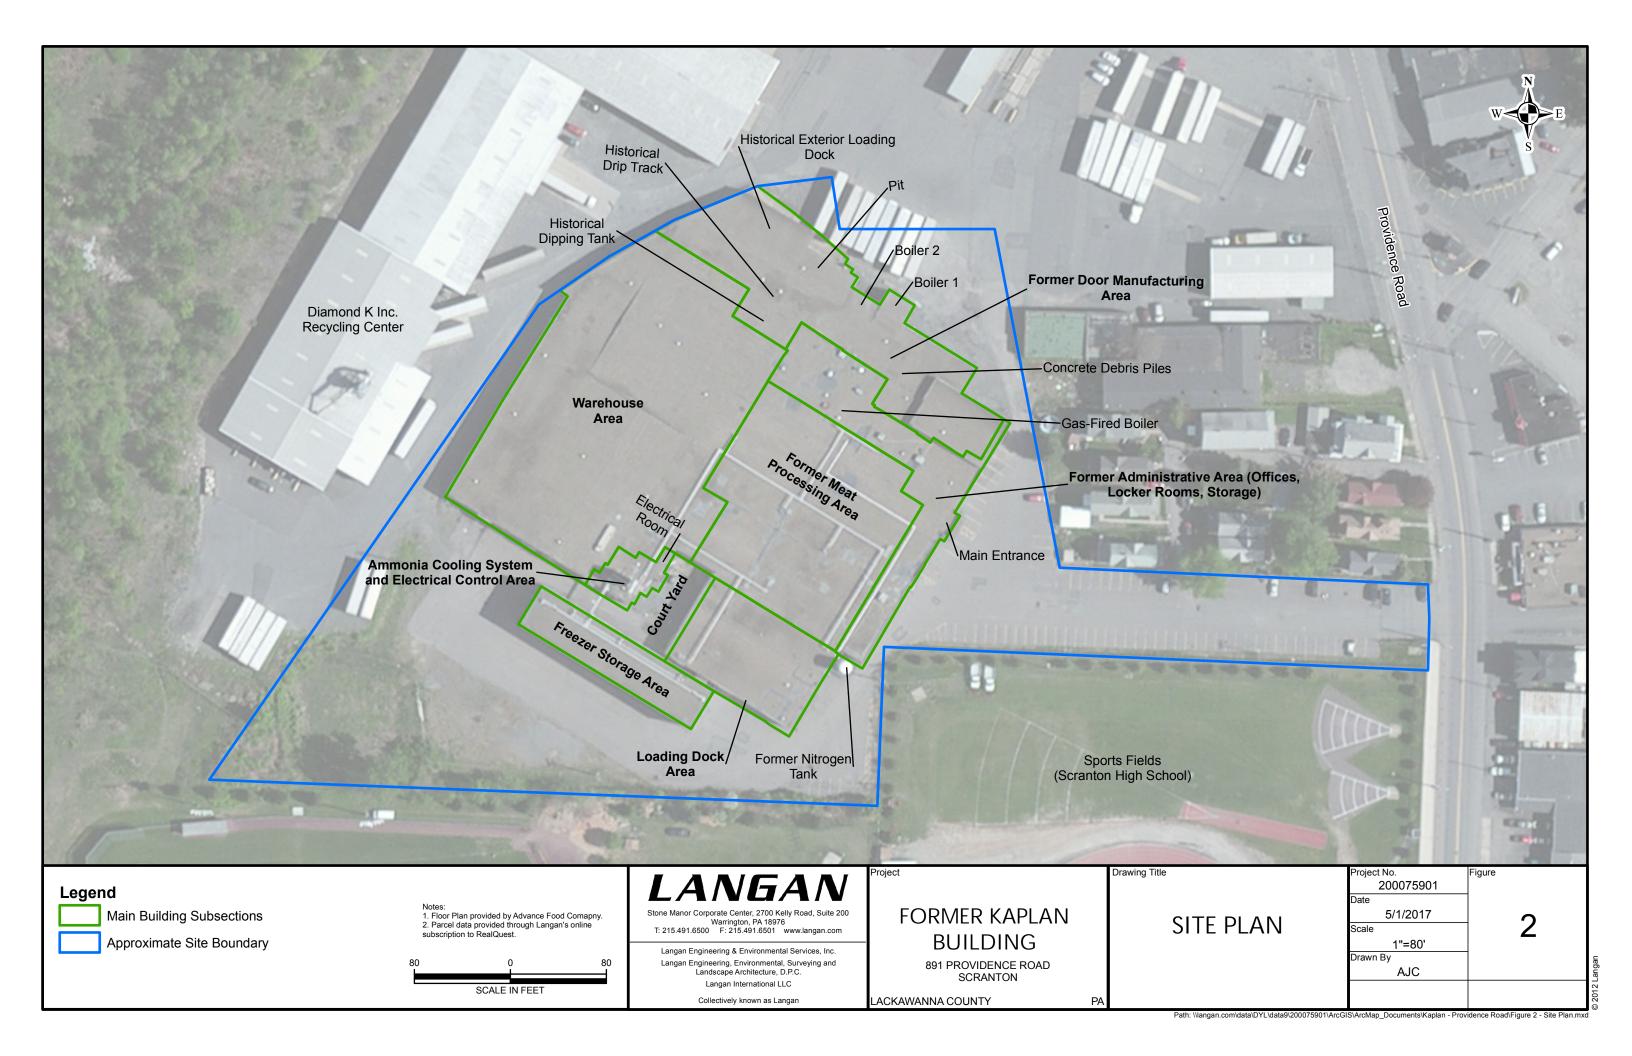
Figure 2 Site Plan

Site location map is included as Figure 1. The building layout and site features are indicated on Figure 2 and the identified RECs and *de minimis* conditions are indicated on Figure 3. This Phase I ESA was completed as part of the environmental assessment process in anticipation of potential site redevelopment.

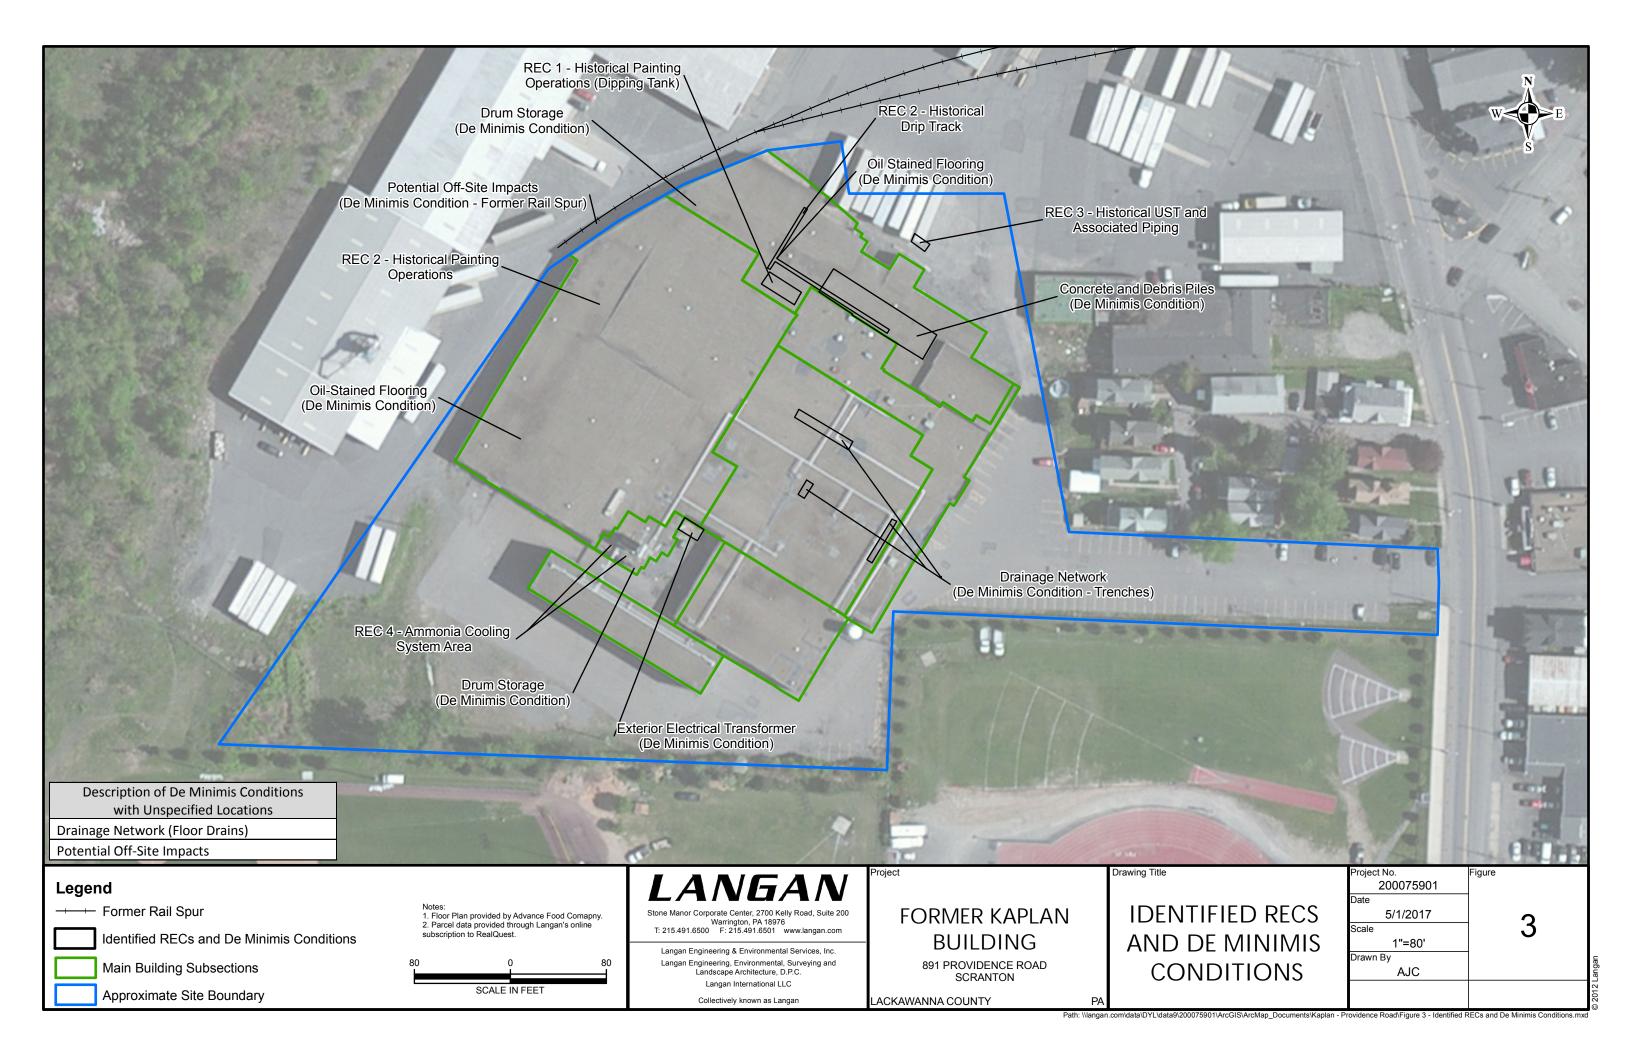
Figure 3 Identified RECs and De Minimis Conditions

Drainage Network
Exterior Electrical Transformer
Concrete and Debris Piles
Oil-Stained Flooring
Drum Storage

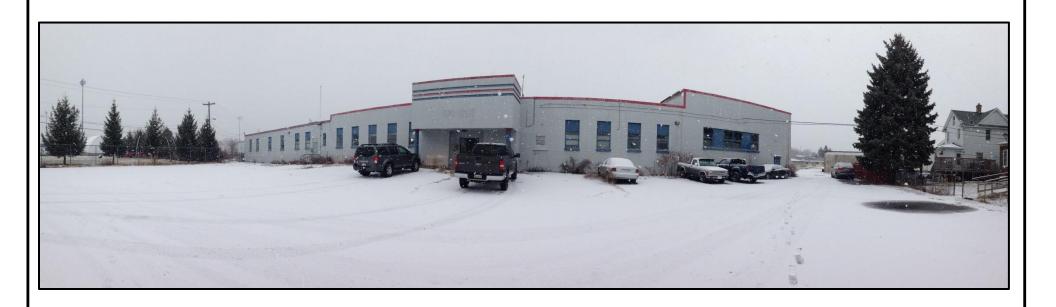
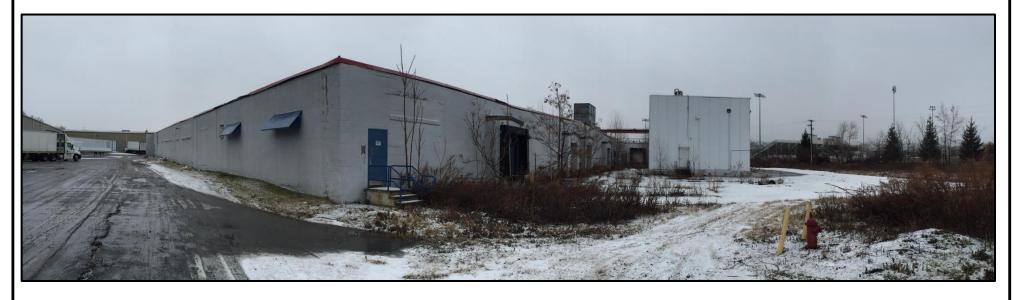
Project No. 200075901	Photo
Date Taken 12/29/2016	H.1
aken By F Δ

Exterior of the facility as viewed from the eastern side entrance (top) and southwestern corner (bottom).

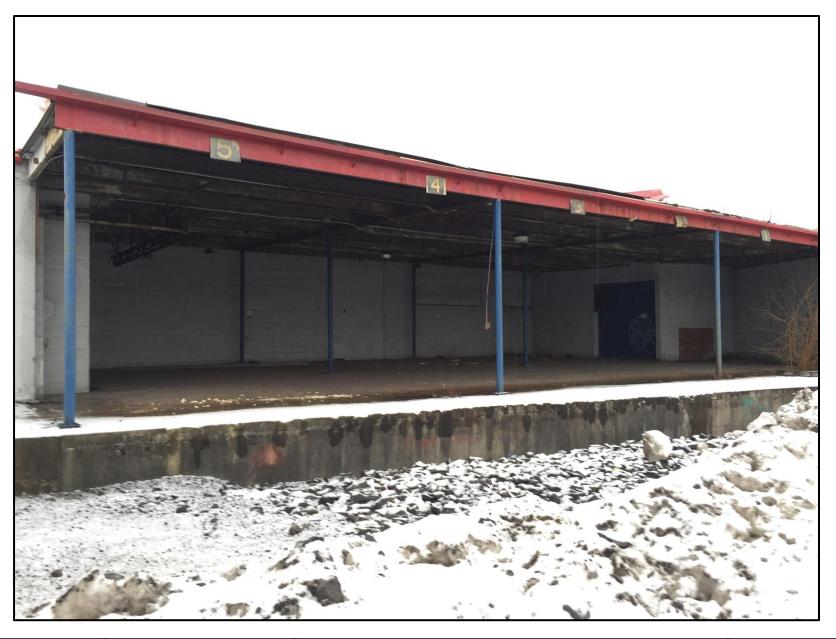
roject No. 200075901	Photo
ate Taken	110
12/29/2016	H.2
aken By EA

Pipes were present along the exterior wall all around the facility. The pipe (left) was observed adjacent to the main entrance on the eastern exterior wall. Natural gas enters the building from the northern exterior wall (right).

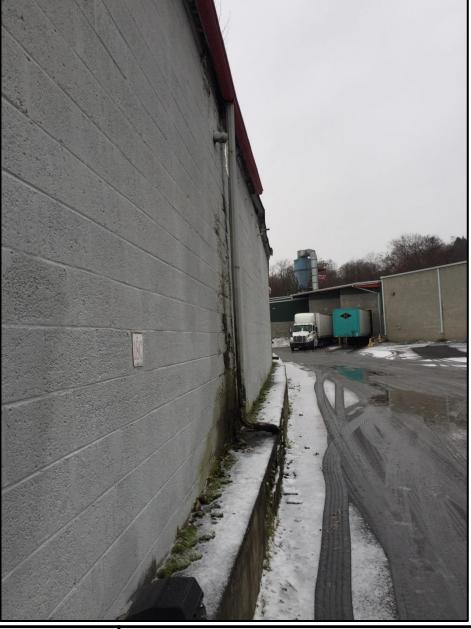
Project No. 200075901	Photo
Date Taken 12/29/2016	H.3
Taken By EA

Exterior loading dock on the northwest corner of the building.

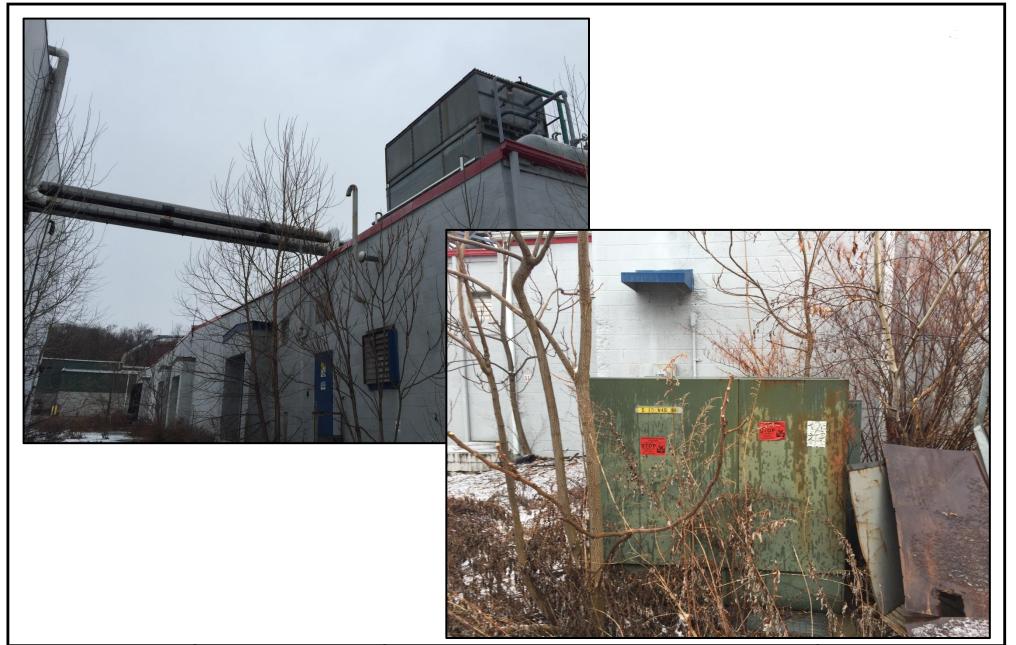
Project No. 200075901	Photo
Date Taken	114
12/29/2016	H.4
Гакеп Ву ЕА

Roof downspouts discharged directly onto the ground around the facility. Downspout (pictured) was located along the northwest wall. One storm drain was observed on the adjacent property to the northwest in an area with gravel pavement.

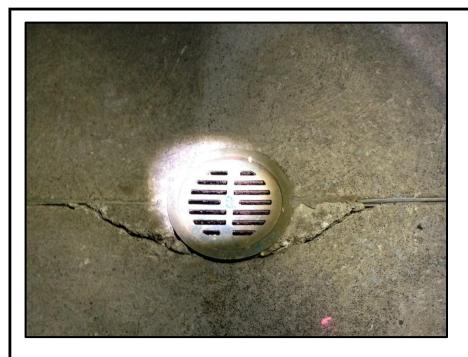
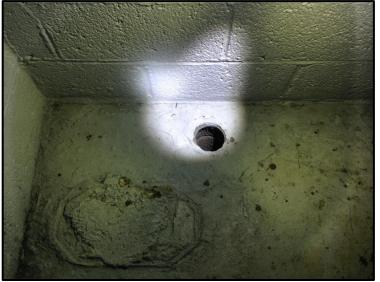
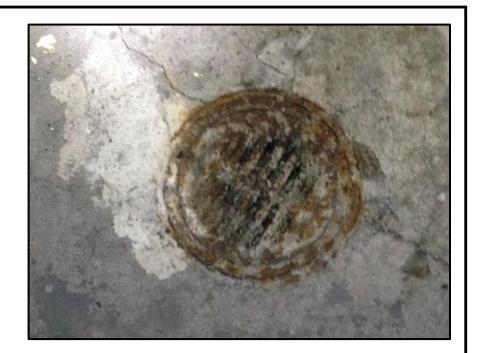
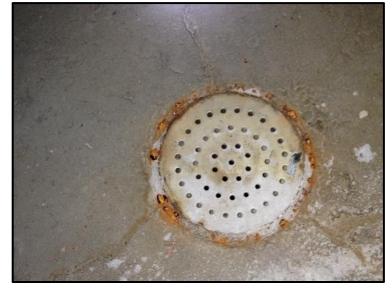
Project No. 200075901	Photo
Date Taken	110
12/29/2016	H.6
Taken By EA

The former meat processing area, as viewed from the eastern side of the room, was identified as the slicing room on maps created by Advance Food Company (top left). Concrete equipment pads were located along the eastern wall, image is oriented to the southwest (bottom right).

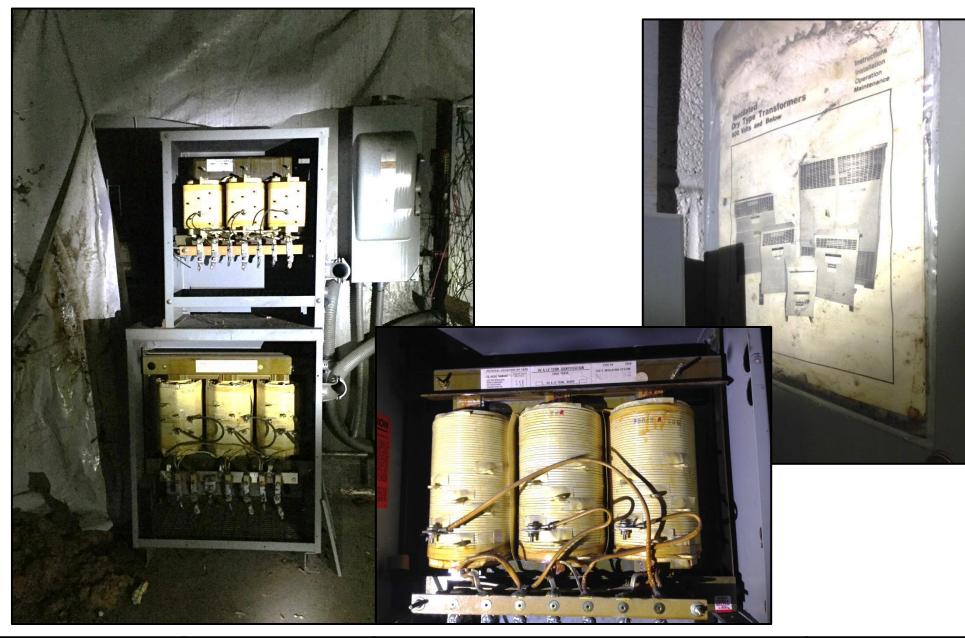
Project No. 200075901	Photo
Date Taken	1144
12/29/2016	H.14
Гакеп By EA

Sump/pipe access and electrical panels located in a small room to the north of the main entrance. A dry type transformer was also located in this room. Pipes (right) were located below floor grade.

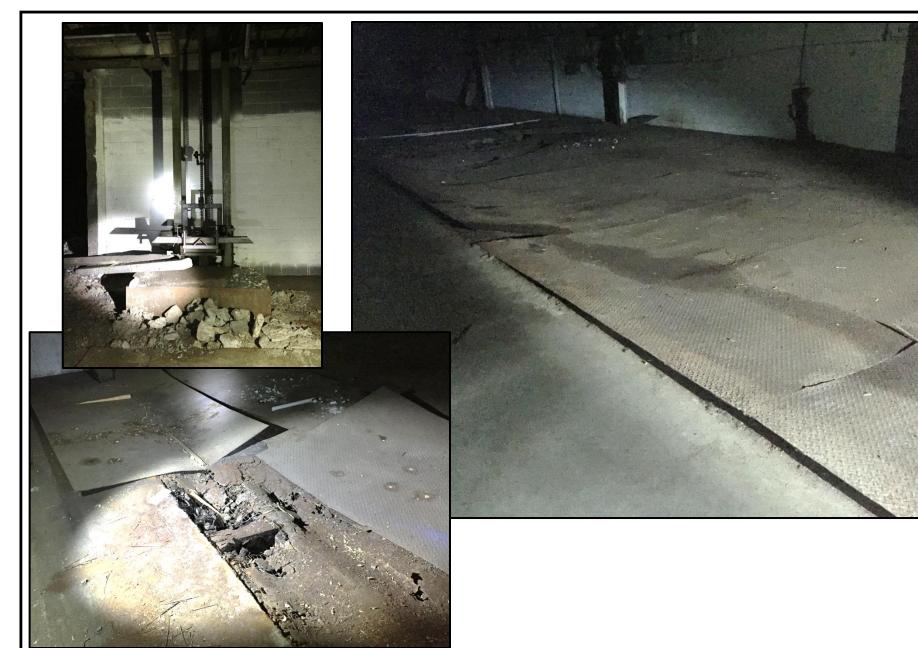
roject No. 200075901	Photo
ate Taken	1140
12/29/2016	H.19
aken By EA

A room identified as the sanitation room was observed to contain the remains of storage structures. Several covered pits were observed and were either filled or rusted shut at the time of inspection.

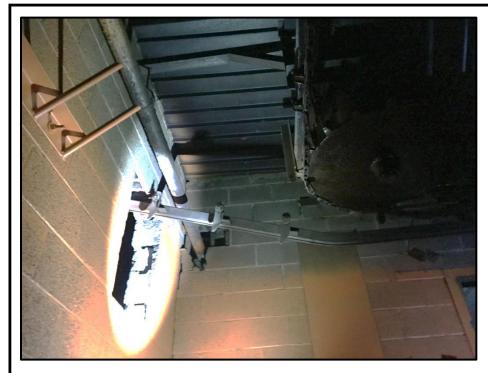
Project No. 200075901	Photo
Date Taken	1100
12/29/2016	H.20
Faken By EA

Metal plates covering a pit believed to be a former dipping tank used by Superior Fireproof Door and Sash Company. The room is located in the northwestern section of the building). Equipment used in former operations (top left) was also observed.

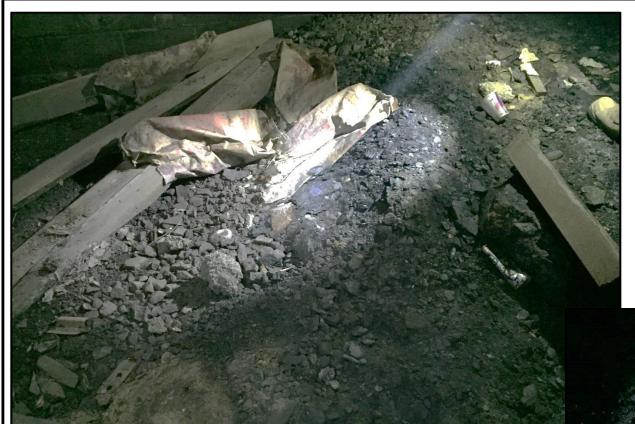
Project No. 200075901	Photo
Date Taken	1100
12/29/2016	H.22
Taken By EA

Piles of debris, mostly consisting of broken concrete, were observed throughout the former door manufacturing area. Concrete cores were observed in debris piles and rebar was not observed in the concrete. The origin of concrete and when it was deposited are unknown.

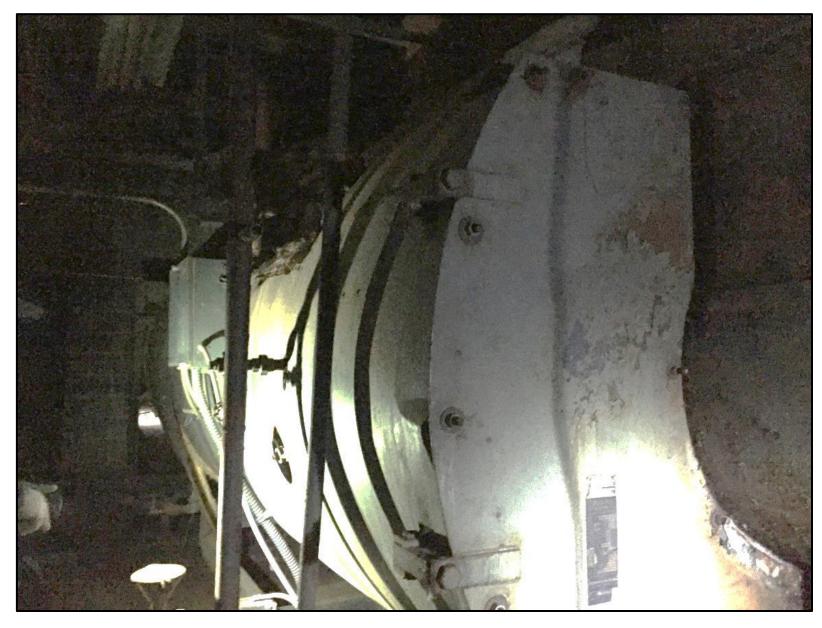
Project No. 200075901	Photo
Date Taken	1104
12/29/2016	H.24
Taken By EA

One of two oil and gas dual-fired boilers (Boiler 1) located on the northern exterior wall of the former door manufacturing area. The boiler is not currently in use.

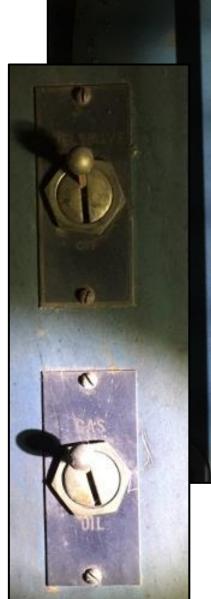
Project No. 200075901	Photo
Date Taken	1105
12/29/2016	H.25
Taken By EA

The second of two large oil and gas dual-fired boilers (Boiler 2) located on the northern exterior wall of the former door manufacturing area. The boiler is not currently in use.

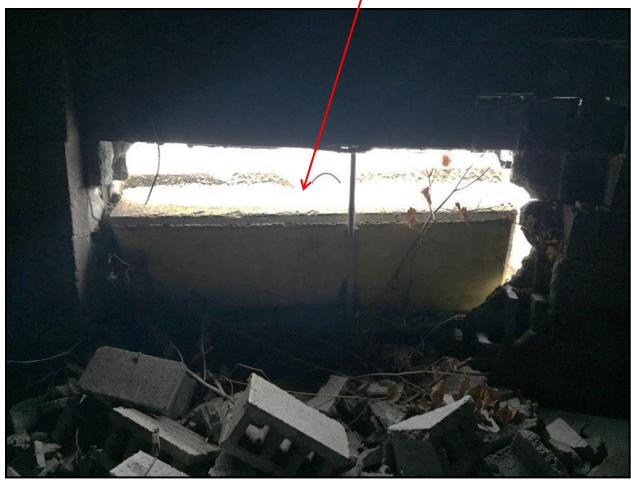
roject No. 200075901	Photo
ate Taken	1100
12/29/2016	H.29
aken By EA

A variety of methods have been used to limit unauthorized access including locking/bolting of doors and placement of objects. Examples are located on the exterior walls along the northeastern wall and the northwestern and southwestern corners of the facility.

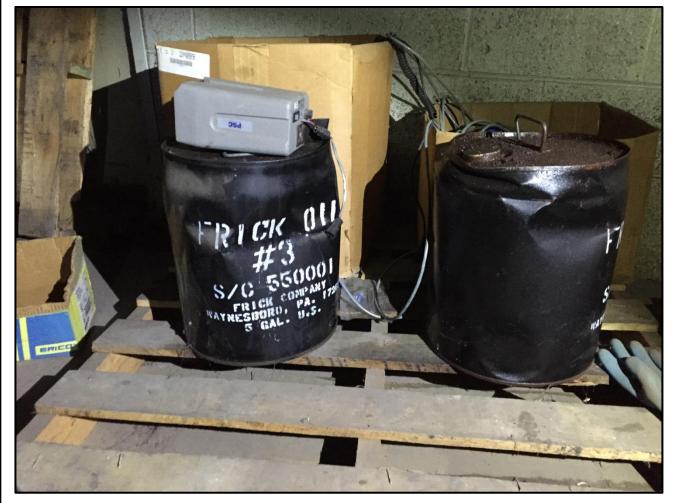
Project No. 200075901	Photo
Oate Taken	1100
12/29/2016	H.30
aken By EA

Four 55-gallon drums of frick oil #3 were found in several areas throughout the building including along the western wall of the warehouse area and the former cooling system and electrical control area.

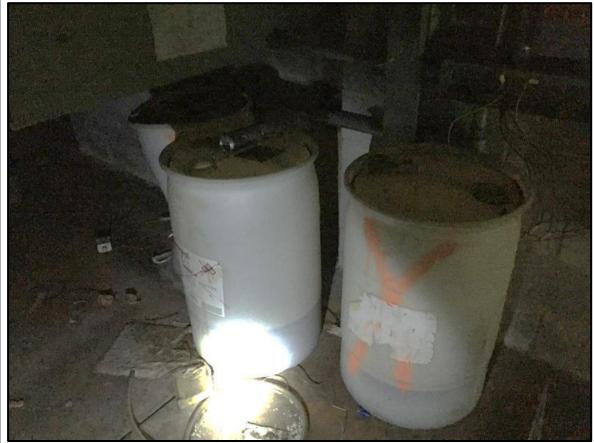
oject No. 200075901	Photo
te Taken 12/29/2016	H.32
ken By

Small volumes of chemicals were present throughout the facility. Waste oil (top right) was not observed but a sign was observed in the western portion of the building indicating that waste oil might have been previously stored there.

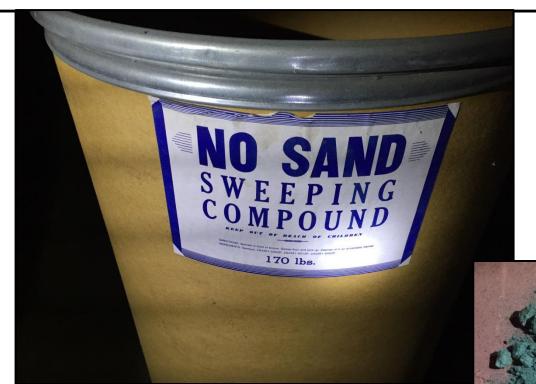
Project No. 200075901	Photo	
Date Taken		
12/29/2016		┦.、
Taken By EA

A no sand sweeping compound was observed to be spilled on the concrete floor in the western-most room of the facility.

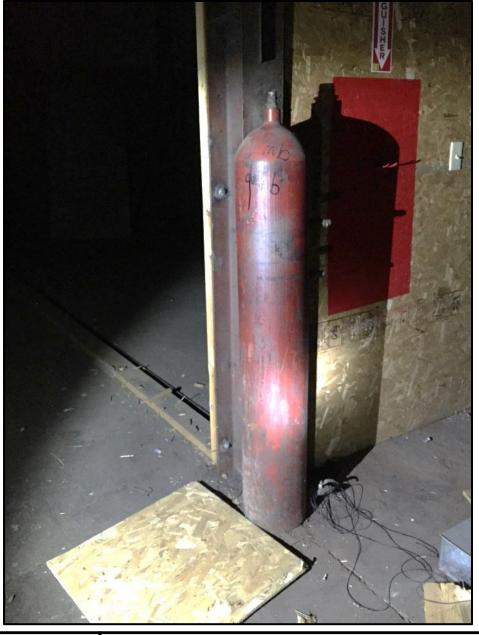
Project No. 200075901	Photo
Date Taken 12/29/2016	H.34
Taken By

A gas cylinder with unknown contents was observed in the warehouse adjacent to a fire extinguisher mount.

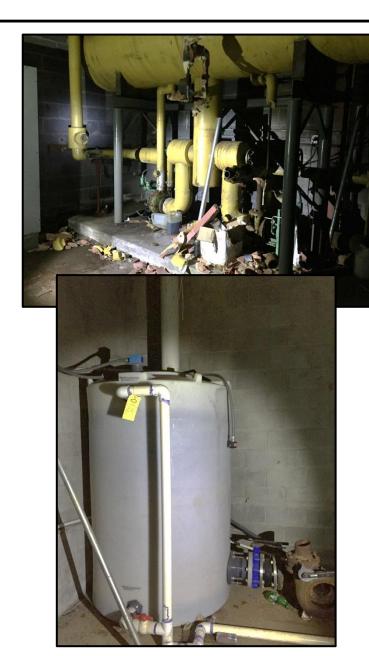
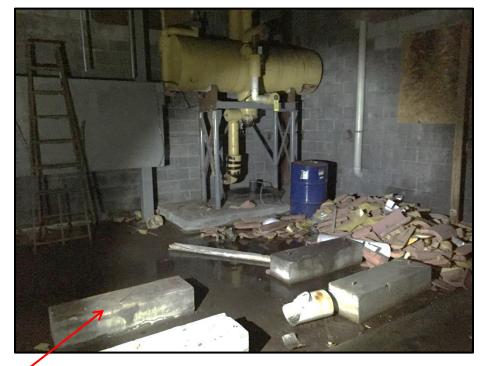
roject No. 200075901	Photo
ate Taken	1107
12/29/2016	H.37
aken By EA

An ammonia coolant system was located in the former cooling system and electrical control area. The system connected to the freezer adjacent to the the southern property boundary. Some equipment had been removed (bottom left).

Former Tank Pad

Control Box

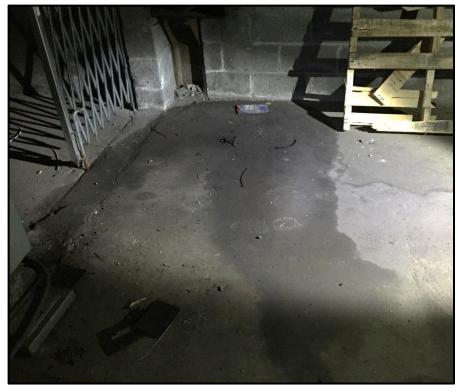
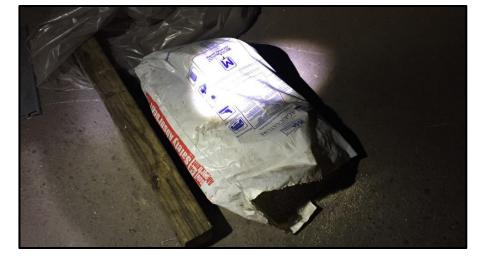
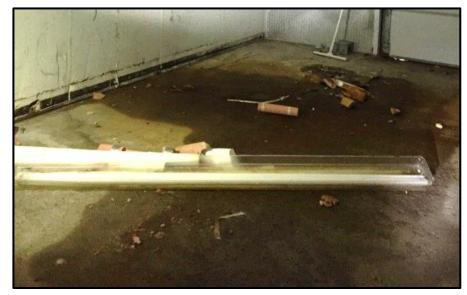
oject No. 200075901	Photo
ite Taken	1100
12/29/2016	H.38
iken By

Additional equipment associated with the ammonia coolant system in the southwestern portion of the facility. A tank with unknown contents was present in the northwest corner of the room. The site contact indicated that four additional upright tanks had been removed from cement pads recently.

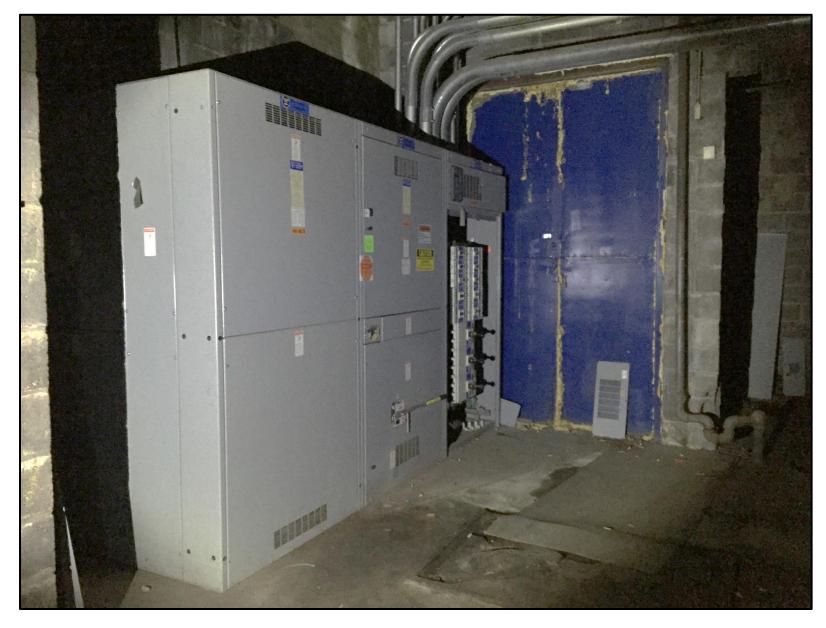
Project No. 200075901	Photo
Date Taken	1 4
12/29/2016	H.40
Taken By

Electrical room and transformer located adjacent to the courtyard south of the main building.
